## Incident information sheet of SEA EMPRESS 1996

## The incident

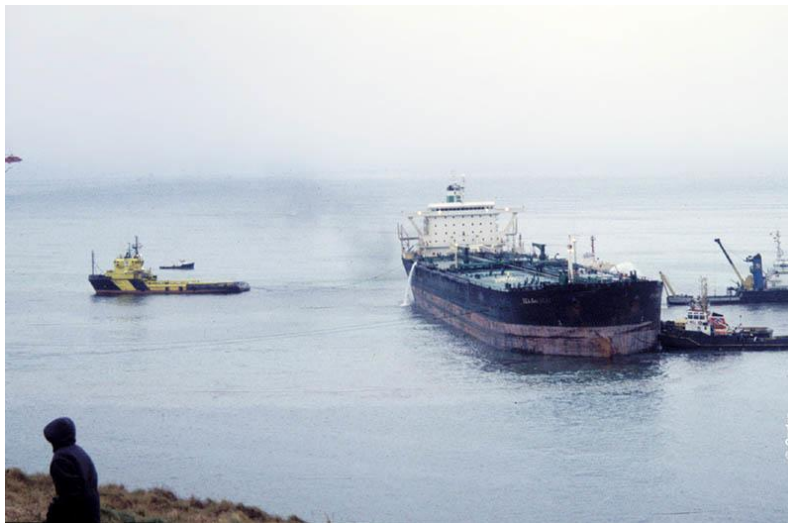
*The Sea Empress aground at Milford Haven ©CEDRE*

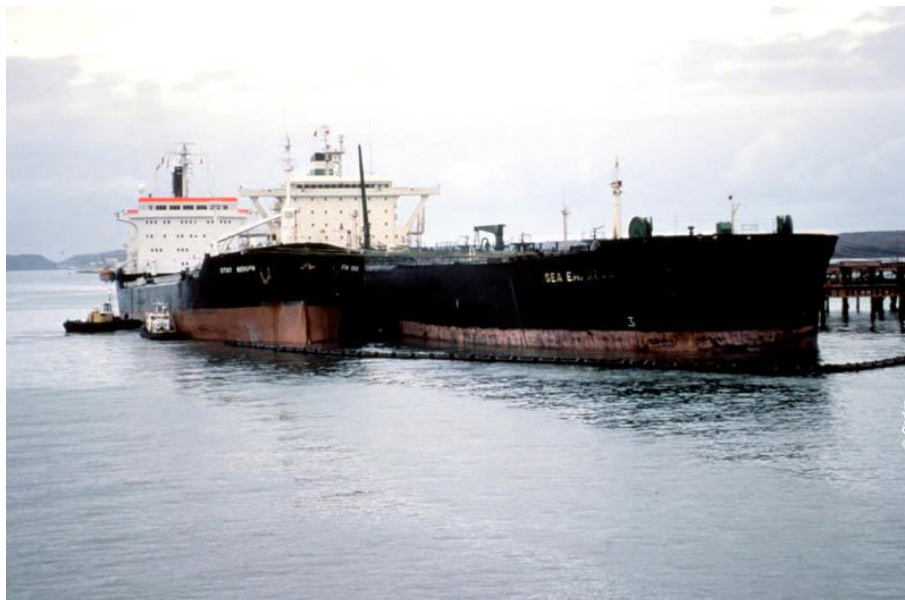
*The Sea Empress during lightering operations at Herbrandston Jetty ©CEDRE*

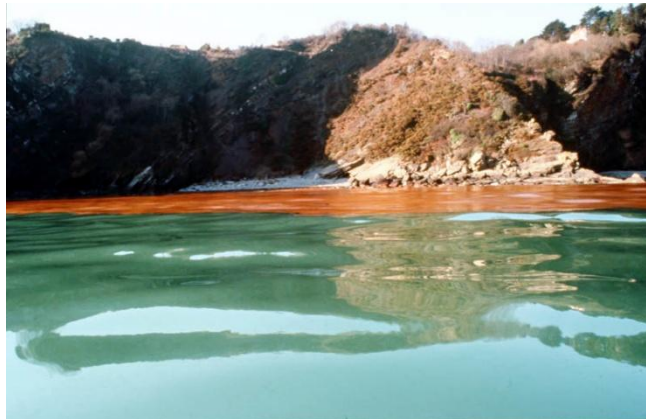
*Emulsified oil in Tandy Bay ©CEDRE*

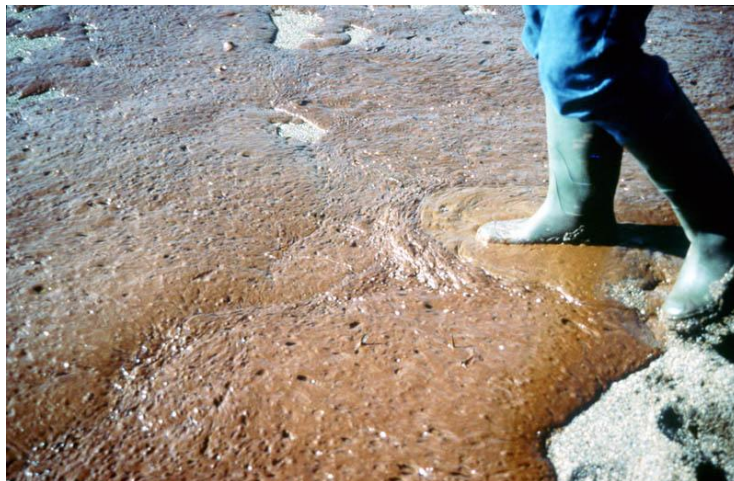
*Emulsified oil on the beach in Swanvilake Bay ©CEDRE*

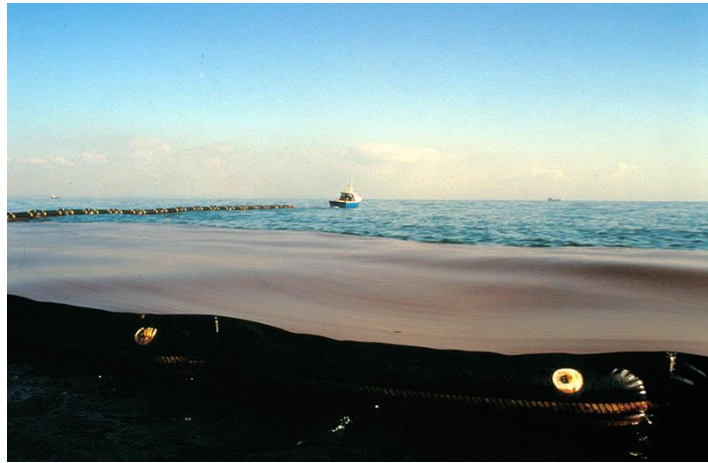
*Oil confined at sea ©CEDRE*

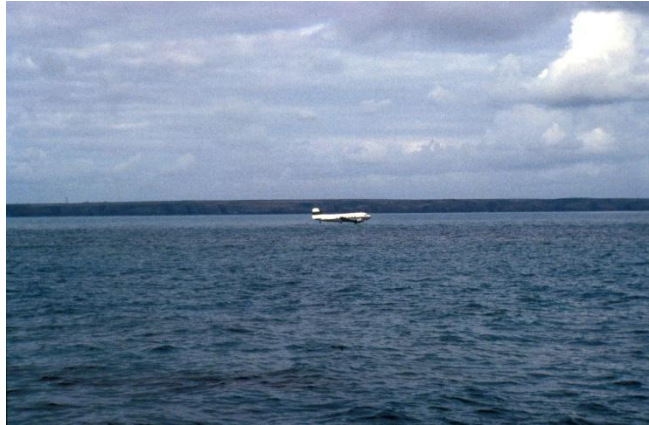
*Spraying of dispersants from the air ©CEDRE*

The treated areas were defined and monitored from teledetection and guide aircrafts from MPCU. Spraying operations from the air were carried out starting one nautical mile from the coast, outside the Bay, and during the ebb tide. These operations were stopped on 23 February as they were ineffective and most of the pollution had reached the coast. The dispersants seemed effective since sampling from AEA Technology showed that oil was dispersing in the water column (10 ppm right after spraying, 1 ppm an hour later).

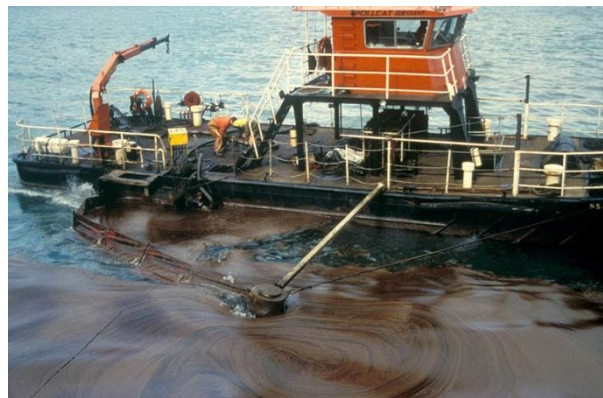
*Le Sea Sweep ©CEDRE*

Oil recovery on the coastline started on 15 February from the recovery boats *Sea Mop* et *Sea Sweep* (capacity: 40 m<sup>3</sup> each), both equipped with an oleophilic rope skimmer.

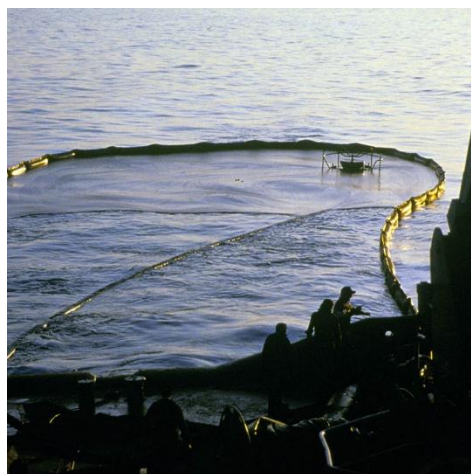
*The TRANSREC recovering oil within a boom ©CEDRE*

Used for the first time in a real-life recovery situation, the TRANSREC 250 system showed great capacities.

The TRANSREC was deployed in a level 4 to 5 sea state; its performances were not impacted. Showing excellent manoeuvrability and operated by only one person, this piece of equipment was undoubtedly the best large-scale skimmer available in the world at that time.

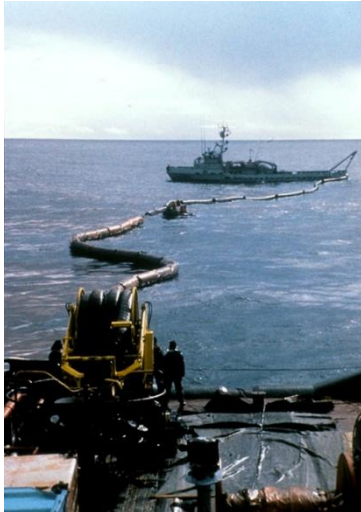
Deployment of the TRANSEC ©CEDRE

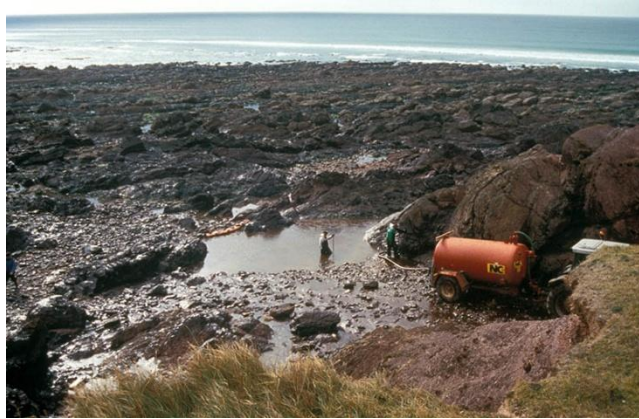
*Oil on shore in West Freshwater Bay ©CEDRE*

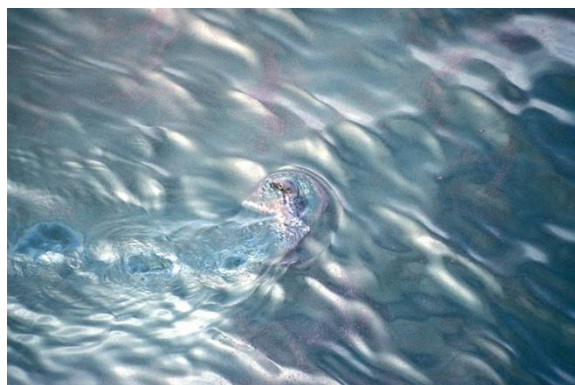
Grey seal in the middle of a slick ©CEDRE

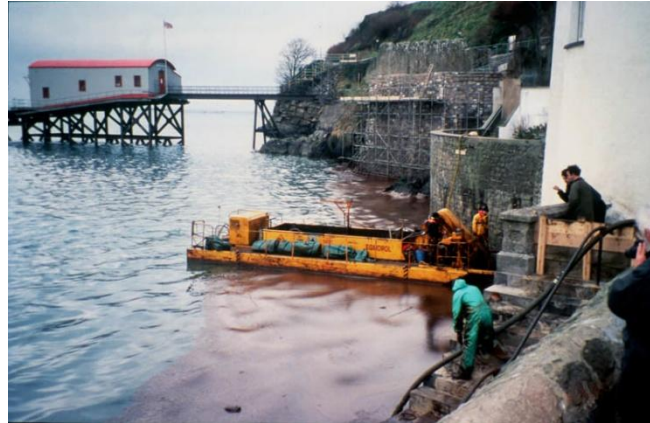
*Egmpol barge in the port of Tenby ©CEDRE*

The barge was used first on 19 February near the oil tanker, which in the meantime had been towed to a terminal located a few kilometres west of Milford Haven. A boom surrounded the vessel to contain the oil still leaking from the gaping holes in the hull. For the first four days, while the lightering operations of the vessel were being organised, the barge recovered around 100 m<sup>3</sup> of oil, totalling 18 hours of work daily.

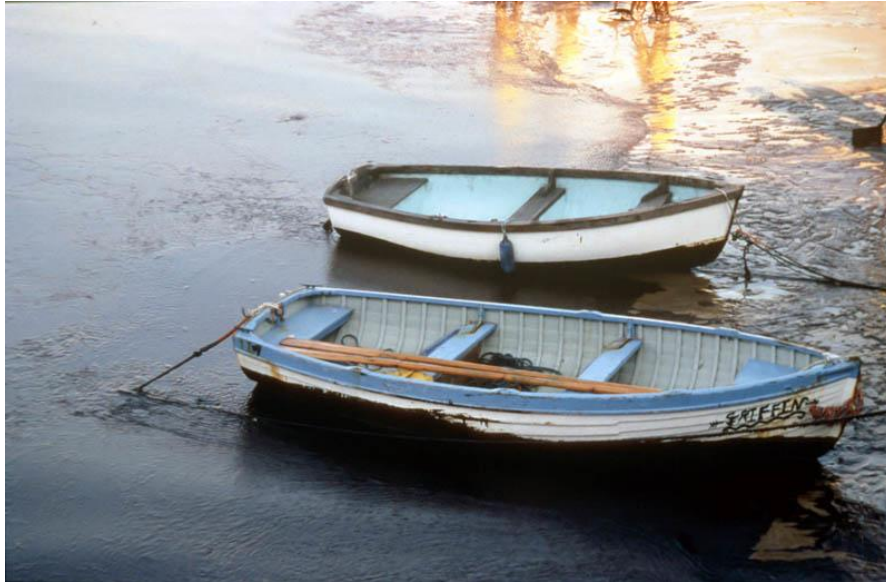
*Oiled fishing boats ©CEDRE*

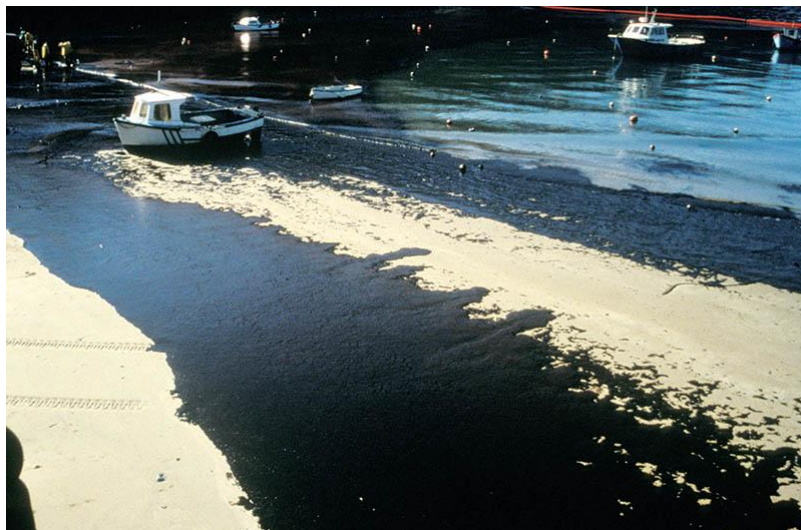
Grounded oil on the beach in Tenny ©CEDRE

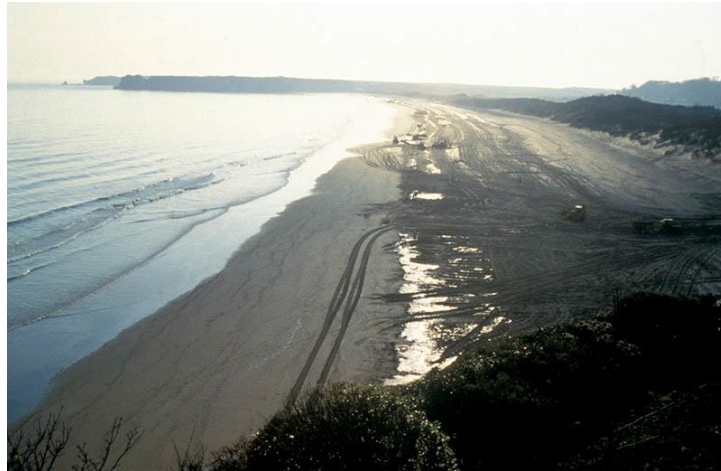
*South Beach twenty days after the incident ©CEDRE*
