## Incident information sheet of ROKIA DELMAS 2006

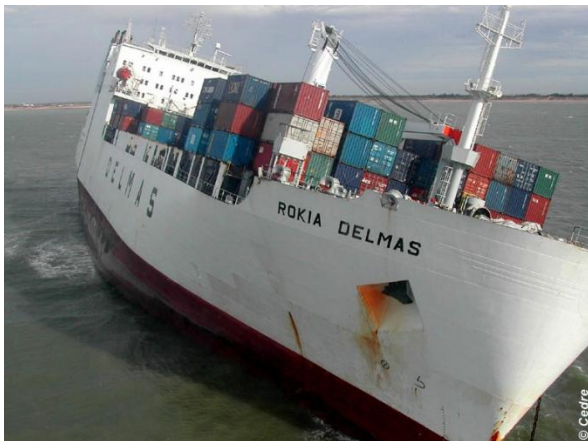
The container ships Rokia Delmas, ran aground on 25/10/06 ©CEDRE

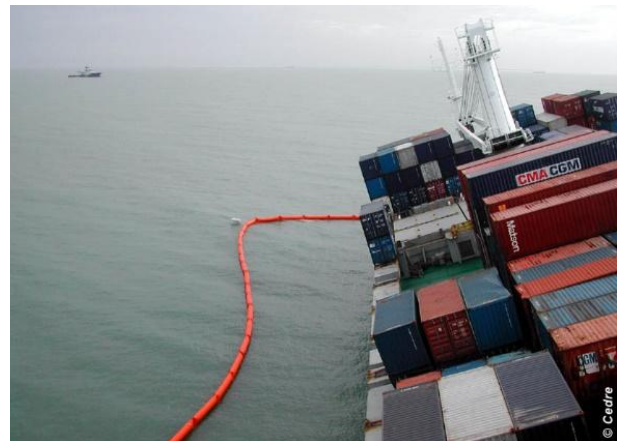
Pollution response boom around the Rokia Delmas ©CEDRE

Alongside the salvage plan was a pollution contingency plan, which consisted of deploying a boom around the whole site and pre-positioning oil recovery equipment (skimmers, sorbents, booms etc.). This equipment was able to be deployed by a response team of 8 people, who could be on site within 45 minutes.

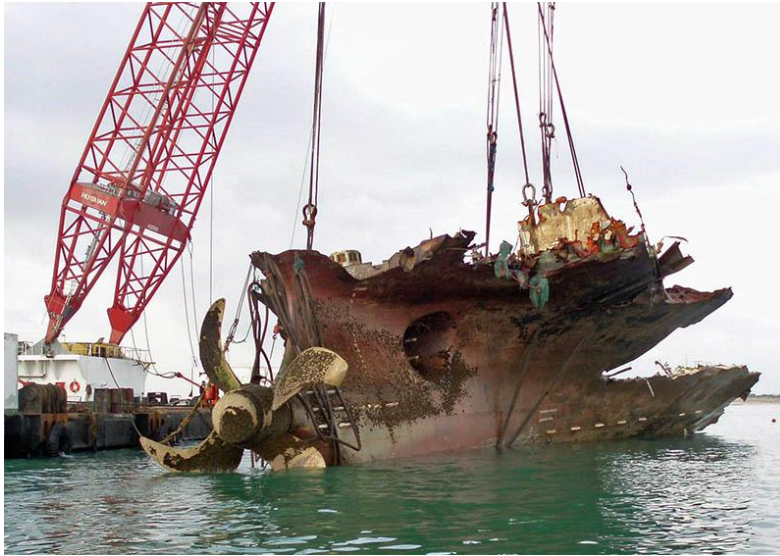
One of the last pieces of Rokia Delmas ©CEDRE

After the superstructures had been removed, it became obvious that the hull could not be refloated and removed as a whole due its deformation. Phase II therefore involved cutting the wreck into 5 vertical sections (steering section, engine section, front section and then middle section cut in two).

The following phase (III) involved the evacuation of each part of the hull to the port of La Rochelle using a crane barge, before final disposal at a demolition site. The last section of hull was hoisted out of the port of La Pallice on the evening of 28 November. An inspection dive took place on 17 December. Some residual debris was reported, and was then removed on 18 December by the worksite operator.

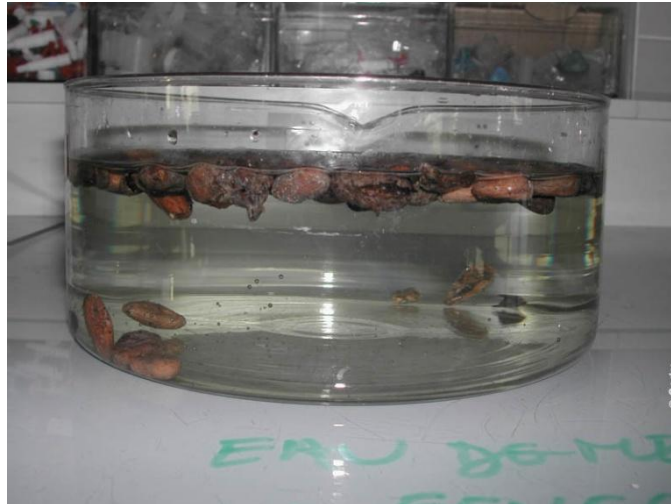
A sample of cocoa beans was introduced in a dish filled with salt water on 31 October. Almost all of the beans in the sample floated. Only some beans sank. After 40 h in the salt water, almost all of the beans were still floating, they were however more submerged.

Dried beans during immersion in sea water ©CEDRE

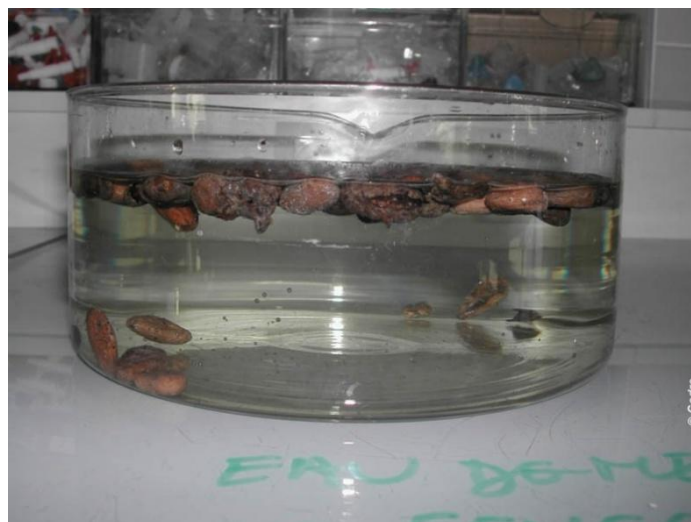
Beans immersed in sea water for 40 hours ©CEDRE

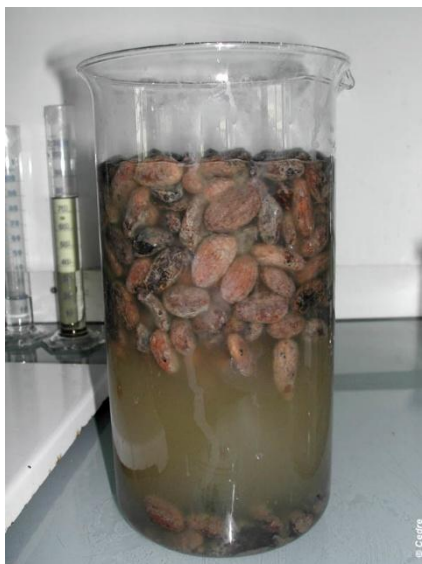
On the third day, a considerable amount of suspended matter was noticed in the water, which became turbid. The beans were sticky to the touch, while still firm. The high content of fat (cocoa butter) might explain this behaviour. On the fourth day, settled matter was noted at the bottom of the dish. As time passed, more beans sank and a white film formed on the surface, indicating the release of lipids. There was still no noticeable gas release or rotting smell.

3<sup>rd</sup> day of immersion in sea water ©CEDRE

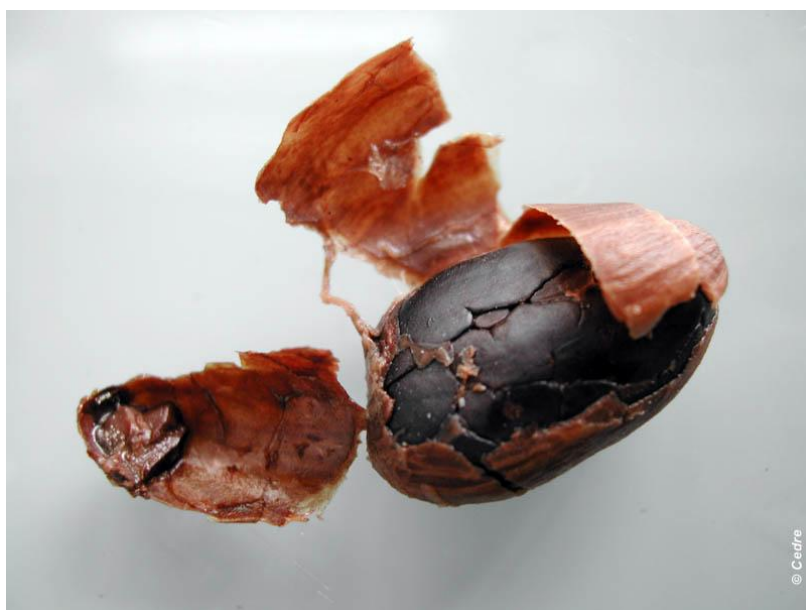
Rinsed bean after 14 days submerged in salt water ©CEDRE

After 14 days, some of the beans were collected and rinsed, observations showed that only the outer protective layer started to decompose while the bean itself remained intact.

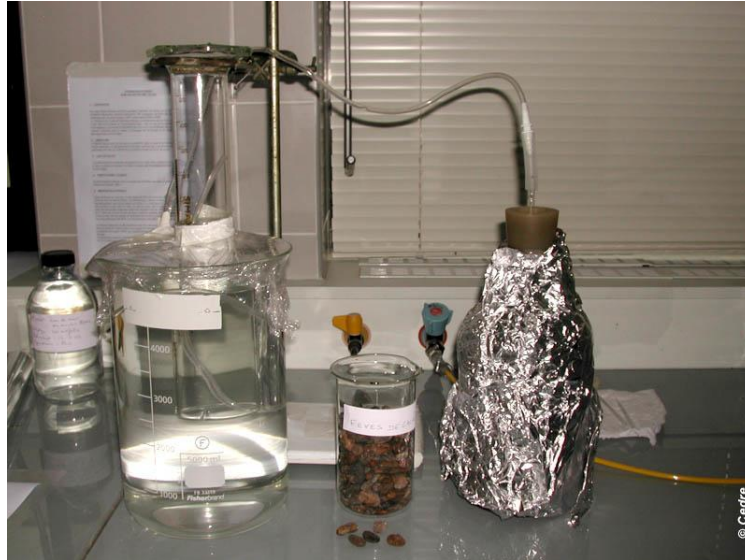
During a second experiment, beans were placed in salt water in an anaerobic environment. A system collected any gas emission.

Experimental device for the collection of gas emissions ©CEDRE

The level of water in the vial progressively decreased as the level of gas increased. After 14 days of testing, an unpleasant rotting smell was noticed, followed by a diminution in the rate of gas released.

After 2 and a half months of test, new hydrogen sulfide measures were taken. They revealed the presence of said gas, generated by the fermentation of the cocoa beans which were kept in salt water in an anaerobic environment.
