## Incident information sheet AMBES 2007

### The incident

On 12 January 2007 at 08h00, a crude oil storage tank belonging to the Canadian company Vermilion Emeraude Rep, located in Ambès (Gironde, France) on the oil storage depot operated by the Société Pétrolière du Bec d'Ambès (SPBA) gave way.

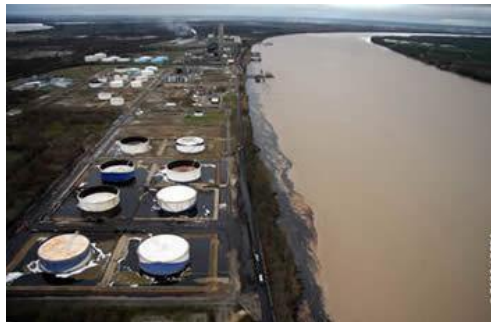
Aerial view of the oil storage and slick on the Garonne, 12/04/07  
©TASO/SPBA

A small part of the oil flowed out of the depot to pollute, on the eastward side, nearly 2 km of marshland trenches and channels, deeply infiltrating into the ground and reaching the water table. On the westward side, the pollution reached a main road and the river Garonne. On the south side, the oil spread over the ground and deeply through channels, it crossed over the main road where most of it was then contained in a parapet along the Garonne. A limited quantity however spilt over the parapet and slightly polluted the upper part of the bank.

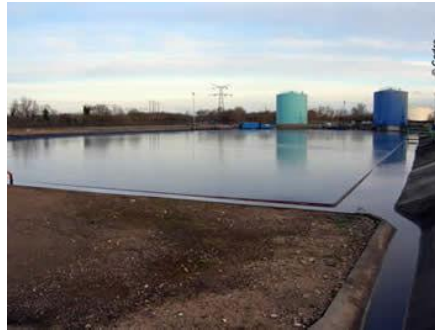
Most of the 2,000 m<sup>3</sup> of oil spilled quickly reached the drainage system, then the settler, meaning that the pumps used to transfer the settled water into the natural environment had to be immediately stopped.

Oil accumulated in the settler ©CEDRE

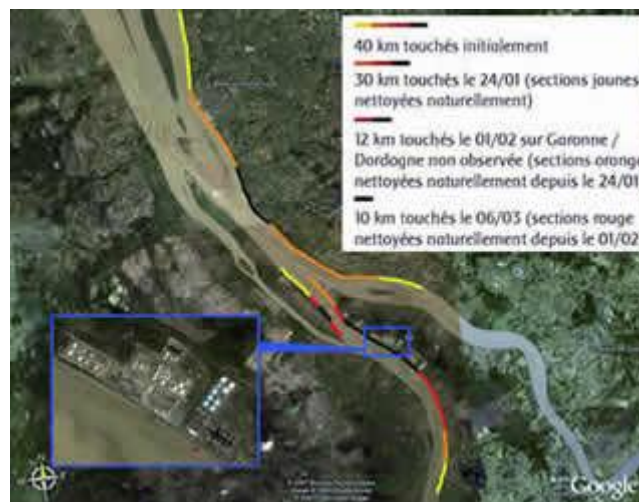
On 13 January, traces of pollutant were observed over 20 km downstream of the depot as well as on the Dordogne. The following tides caused 40 km of embankments of the Garonne, the Dordogne and the Gironde rivers to be polluted. The most heavily polluted 10 km were the right banks of the Garonne and the Gironde.

Evolution of natural cleanup on the banks ©GOOGLE EARTH

It was not thought necessary to conduct final clean-up operations on the banks of the Garonne, as these areas were difficult to access, dangerous, sensitive to excessive trampling and subject to a high level of natural clean-up by the river. Furthermore, nautical reconnaissance carried out by CEDRE on 13 and 24 January showed rapid rinsing of oiled vegetation: the 10 km the least affected had been naturally cleaned by 24 January.

The reconnaissance survey conducted on 6 March showed that only 10 km were still polluted and that the vegetation had begun to grow back on the banks. The reconnaissance survey conducted on 5 April showed that the stretch still polluted had reduced to 3 km on the right bank of the Garonne. The last survey on 3 July showed only 3 small clutters of oiled vegetation close to the depot.

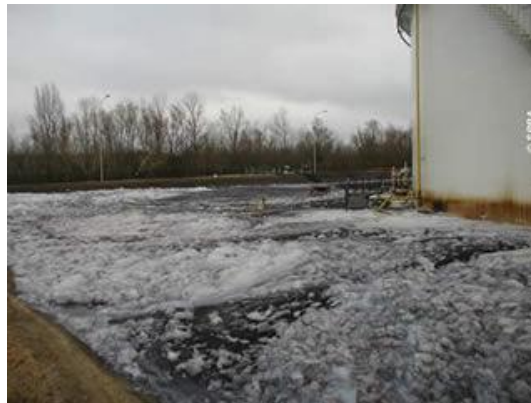
Foaming agent sprayed in the retention tank ©CEDRE

- alerting authorities and fire service
- activating the internal emergency plan
- switching on foaming agent spraying systems to prevent evaporation of volatile fractions and thus reduce the risks of fire
- evacuating all personnel onsite
- stopping operations and cutting the power
- requesting the closure of the nearby major road.

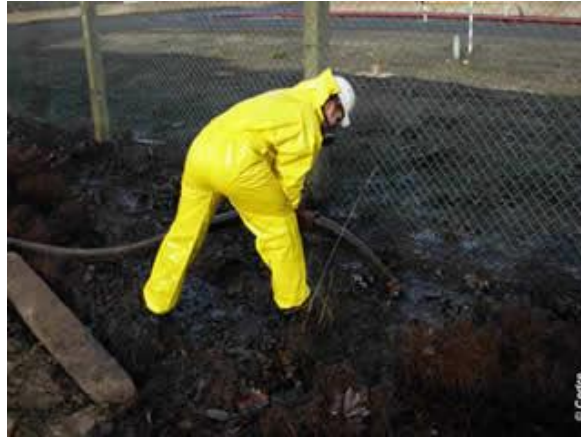
Pumping of the pollutant outside of the depot ©CEDRE

From 12 January, major pumping operations were conducted on the main road, in the trenches and in the drainage ditches. The rainwater drainage ditches were plugged with earth. Meanwhile, dispersants were applied. The river traffic was temporarily interrupted, but resumed later the same day to promote mixing of the oil in the water column.

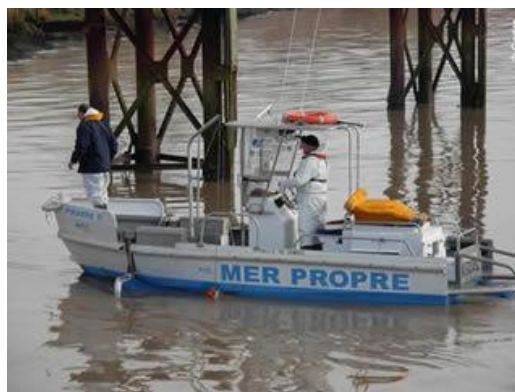
Collection of waste by the recovery unit ©CEDRE

The Piranha oil recovery unit, a boat able to navigate in very shallow waters, arrived onsite. It was equipped with side nets designed to recover floating waste in the Mediterranean ports. The Piranha began the dynamic recovery of trails of pollutant

and floating waste. Its efficiency was later improved by filling the bottom of the nets with sorbents.
